APPENDIX 5

Long-Term (Post-Construction) Stormwater Measures

NMSU Storm Water Structures Inventory

MS4 Basin and Structures Screening Data

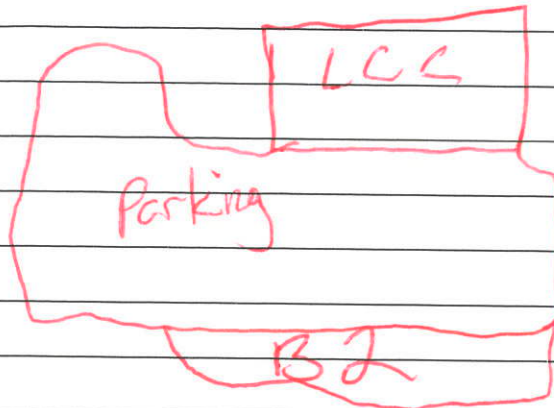
Structure is South of Las Cruces Convention Center parking lot and North of College Avenue. Detention pond is made up of heavy rock/concrete and is also secured on all sides with fencing. No structural or illegal dumping was noticed at the time of inspection. Pond integrity is sufficient enough to provide proper flow. There is no obstruction to flow. No maintenance and no other issues for Basin 2.

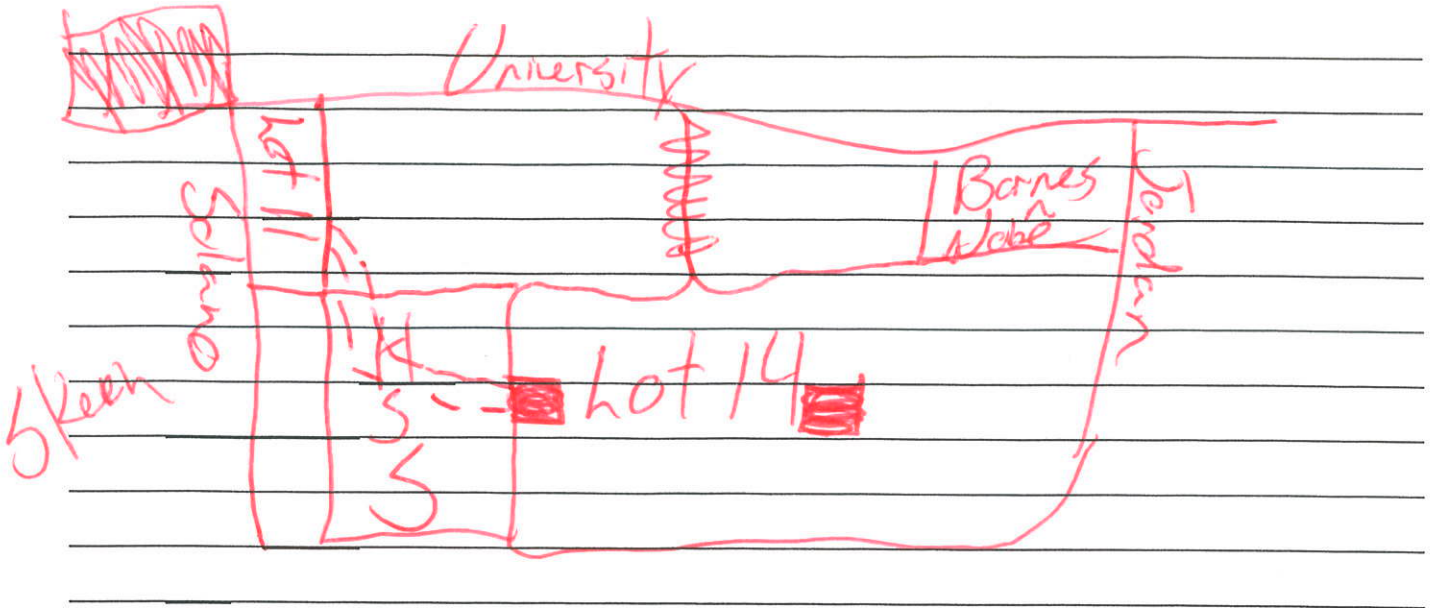
Basin 4 - 1. Corner of Knox and University is clear of obstruction and seems to be operating with free flow. No illegal dumping noted at the time of inspection. Integrity of the various curb cuts do not require any maintenance.

Basin 4 - 3. Drop inlets within the parking Lot 14. In front of Health and Social Services building. Structures are made up of concrete and metal. Structures convey flow to Lot 11 and seem to be free of obstruction or any debris. There was no illegal dumping at the time of inspection and structure does not require any maintenance.

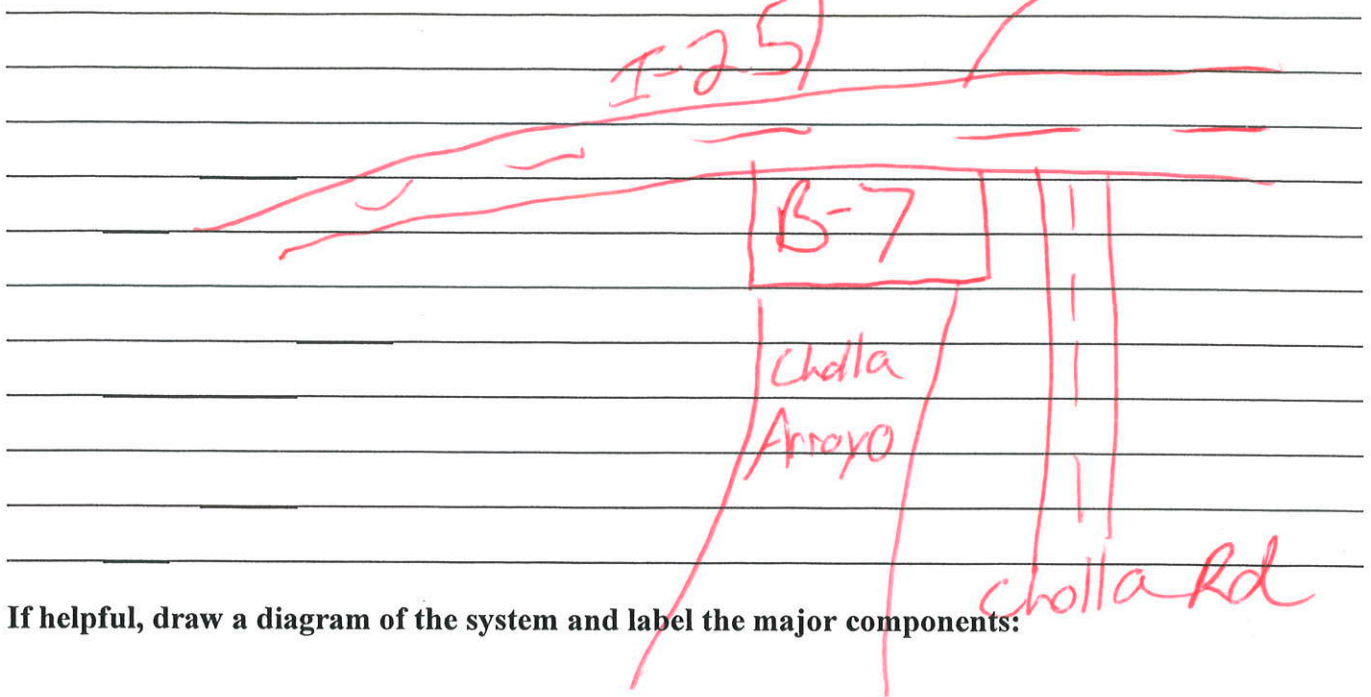
Basin 7 storm water structure is West of I-25 and South of Cholla Street. Five 24" inch corrugated metal discharge/concrete culvert. No illegal dumping noted at the time of inspection. Structure is free from obstructions and integrity is sufficient enough to provide proper flow. Structure is free of any damage and does not require maintenance.

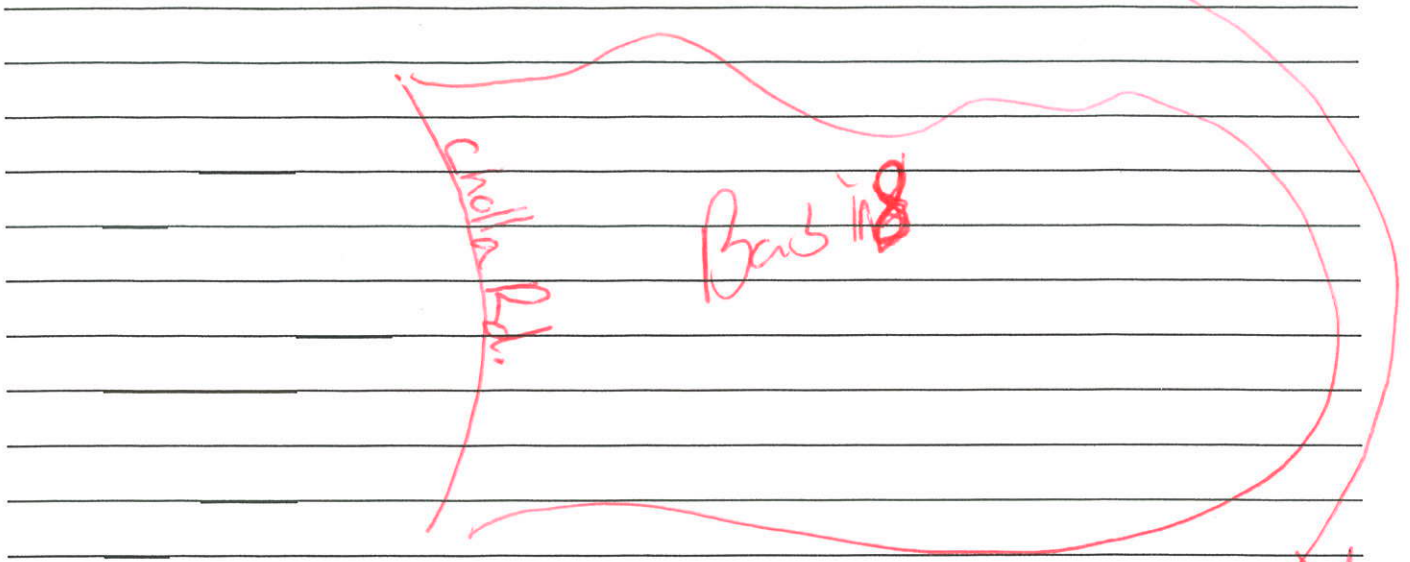
Basin 8 is located South of NMSU Main campus and contains no named or significant arroyos, and is characterized by sheet flow and preferential drainage to a discharge point under Interstate 10. The area is free of any debris and there was no noted illegal dumping at the time of inspection. Since there are no storm water structures in this area there is no maintenance needed.
