MS4 Annual Report Format

New Mexico State University

What size population does your MS4(s) serve? 20,318 NPDES number NMR04L002

What is the reporting period for this report? (mm/dd/yyyy) From July 1, 2025 to June 30, 2026

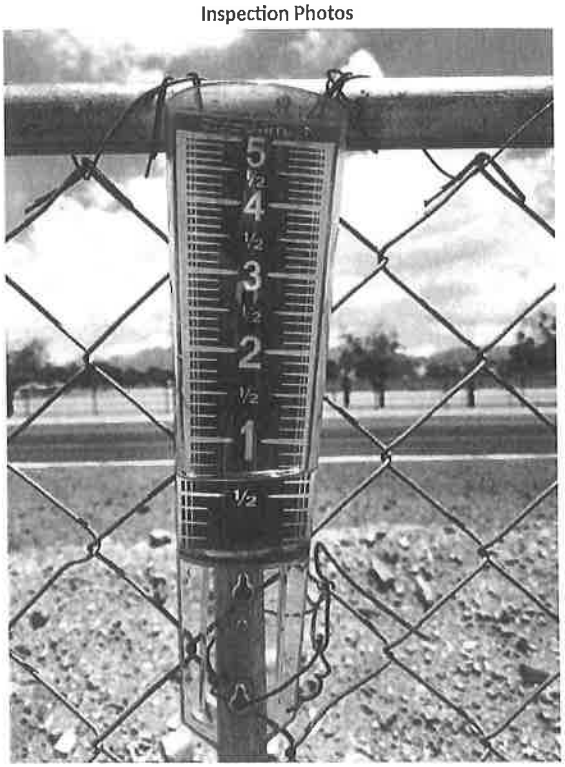
Rain gage 6-26-25

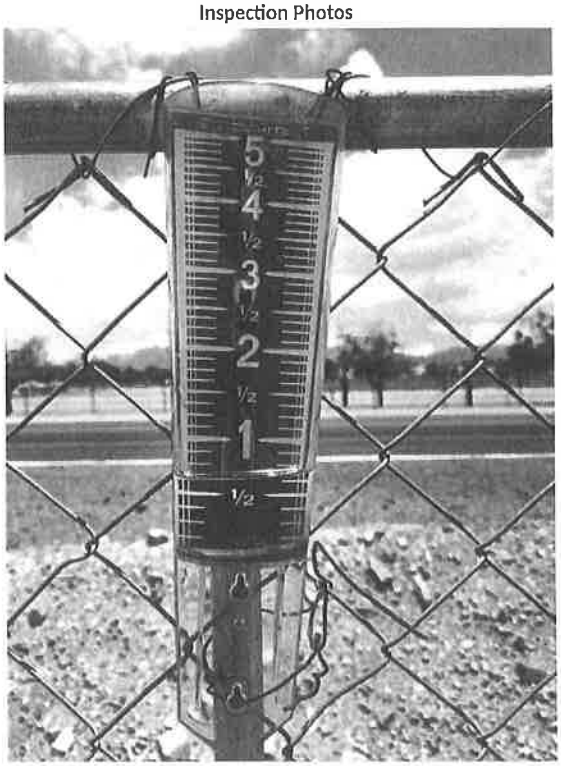
Rain gage 6-26-25

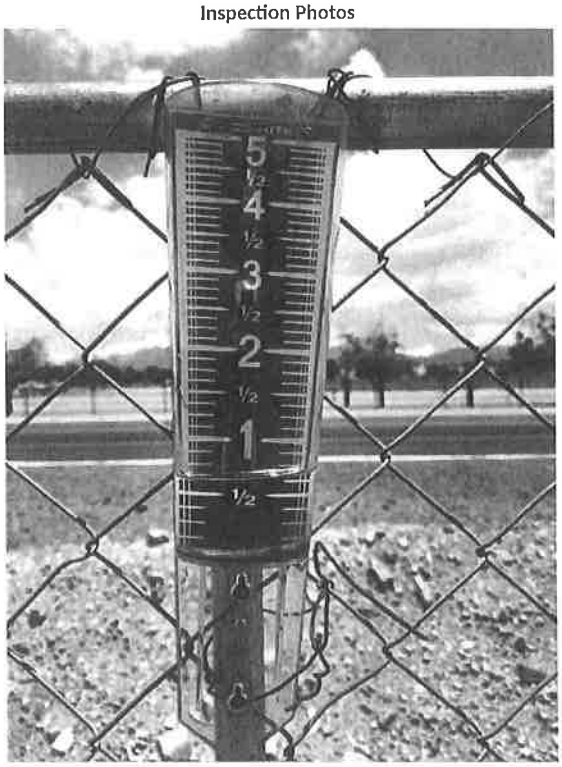
Rain gage 6-26-25
